A comparative study to evaluate the shear bond strength of two commercially available intraoral ceramic repair systems with Ni-Cr base metal alloy- An in vitro study.

Background: Metal ceramics, are normally used materials nowadays in Prosthodontics. These materials are used to fabricate dental prostheses which replace missing or damaged dental structures. This existing research was undertaken to differentiate and appraise the shear bond strength of two commonly obtainable intraoral repair systems for dental ceramics.

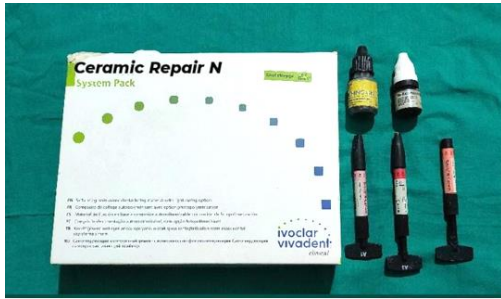
Fig 1.

This research was undertaken to differentiate and evaluate the bond (shear) strength of two economically obtainable ceramic patch-up systems i.e. Ceramic N system (Fig. 1) and Clearfil system (Fig. 2).

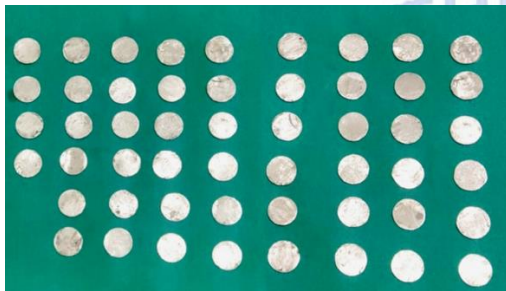
Fig 3.

Total 56 Ni-Cr (Bellabond, Bego, Germany) base metal alloy metallic discs (Fig. 3) were fabricated with dimensions 1.5 mm thick and 20mm diameter using a metallic die (Fig. 4).

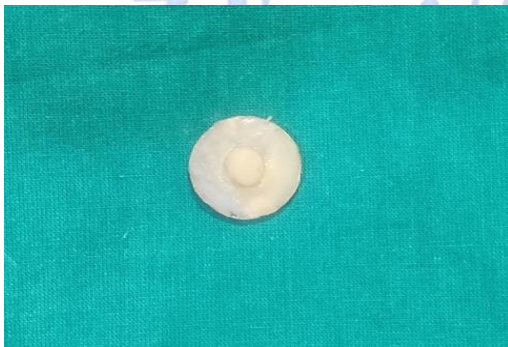
Fig 5.

After that, repairing of all samples with the respective ceramic systems was carried out according to the given instructions by the manufacturer (Fig. 5). After that, every repaired sample was, placed in water (distilled) for the next 24 hours before thermo-cycling. Thermo-cycling was done at 60° C. After the thermo-cycling procedure, the samples were placed in distilled water for a week. Then testing by universal testing

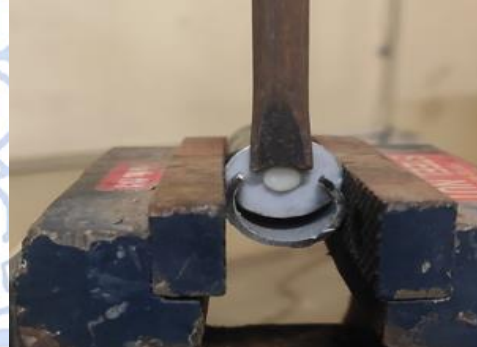
Fig 6.

machine was done with 10 KN (Kilo-Newton) load and the values were recorded (Fig. 6).
