## **A comparative study to evaluate the shear bond strength of two commercially available intraoral ceramic repair systems with Ni-Cr base metal alloy- An in vitro study.**

**Bibliographic details:** Journal of Orofacial Rehabilitation Vol. 3(1), Apr 2023, pp. 3-10.

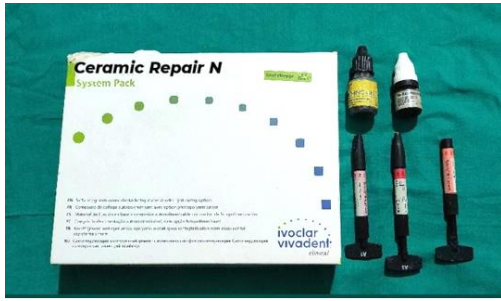
Fig 1.

This research was undertaken to differentiate and evaluate the bond (shear) strength of two economically obtainable ceramic patch-up systems i.e. Ceramic N system (Fig. 1) and Clearfil system (Fig. 2).

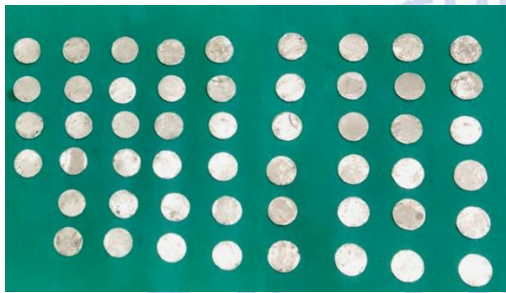
Fig 3.

Total 56 Ni-Cr (Bellabond, Bego, Germany) base metal alloy metallic discs (Fig. 3) were fabricated with dimensions 1.5 mm thick and 20mm diameter using a metallic die (Fig. 4).

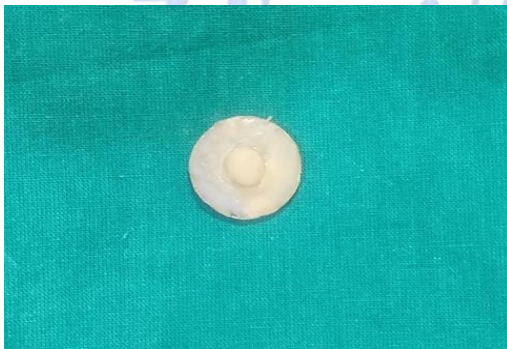
Fig 5.

After that, repairing of all samples with the respective ceramic systems was carried out according to the given instructions by the manufacturer (Fig. 5). After that, every repaired sample was, placed in water (distilled) for the next 24 hours before thermo-cycling. Thermo-cycling was done at 60° C. After the thermo-cycling procedure, the samples were placed in distilled water for a

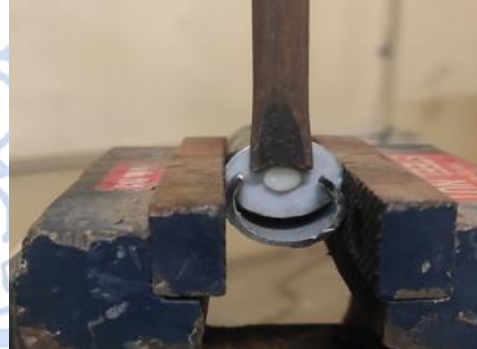
Fig 6.

week. Then testing by universal testing machine was done with 10 KN (Kilo-Newton) load and the values were recorded (Fig. 6).

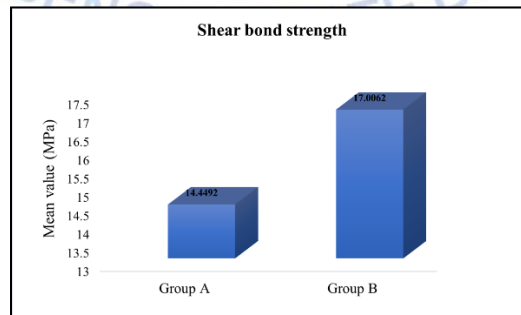
Figure 7. Shear bond strength of group A and group B samples.

Data were entered into the excel sheet (Table No.1). Data were analysed using SPSS (Statistical Package for Social Sciences) 21.0 version. Data were analysed for probability distribution using Kolmogorov-smirnov test, p value  $>.05$  indicated that the data were normally distributed. Descriptive statistics was performed. Inter-group comparison of continuous variable was done using Independent 't' test. p value  $<.05$  was considered statistically significant. Values of mean shear bond strength for group (A) was 14.44 MPa and for group (B) 17.00MPa was obtained (Table No. 2 and 3). While differentiating the value (mean) for group B was significantly superior than group A (Table No. 4 and 5) (Fig. 7).
