## Restoration of anterior teeth with different types of post and core: A case series.

### Abstract

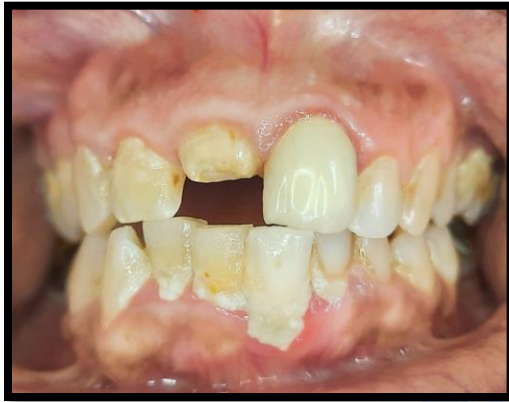
Picture-1A

A 23 year male patient came to the clinic with the chief complain of broken upper right front teeth where endodontic treatment was

attempted elsewhere (Picture-1A). On examination it was revealed that patient had an Ellies class III fractured right upper central incisor with only 2 mm teeth structure present buccally and palatally. There was no tenderness on percussion or mobility of teeth and vitality test was negative. Radiograph showed no peri-apical radiolucency and no open apex.

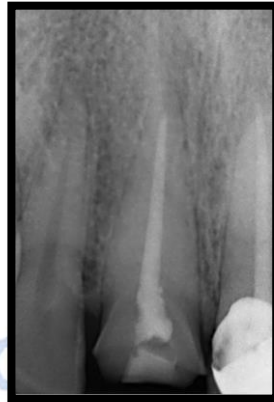
Picture-1B

Access opening was done using No.2 round bur and working length determined using apex locator. Bio-mechanical preparation was done and canal was enlarged up to 40K file using step back technique (Picture-1B).<sup>[7]</sup> After 7 days next appointment was given and gutta-percha was removed by No. 4 peeso-reamer (MANI,INC. Japan) leaving 4 mm GP apically (Picture-1C). Stainless steel post (Coltene ParaPost Stainless Steel, 0.90mm) was selected and inserted in the canal to check the fit. Dual cure cement (RelyX U200, 3M India Limited) was used for post cementation. The catalyst and base components of the material were mixed and applied following manufacturer's instruction. The post was seated and excess material removed before light curing (Picture-1D). Core build up was done with composite (Filtek Z350 Xt, 3M India Limited). Tooth preparation was done (Picture-1E) and upper and lower elastomeric Impression was taken and crown cementation was done after 4 days (Picture-1F).

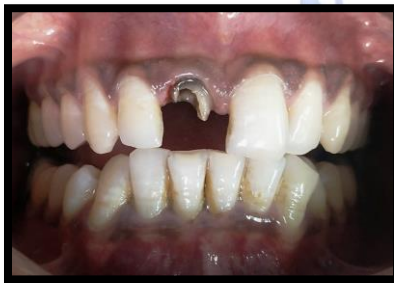
Picture-2A

A 26 year male reported to the clinic with a broken tooth with history of trauma 16 years back. On intra oral examination it was noticed teeth had an Ellies III fracture with significant loss of crown structure (Picture-2A). Periapical radiograph showed no open apex and no peri apical infection. The vitality test was negative.

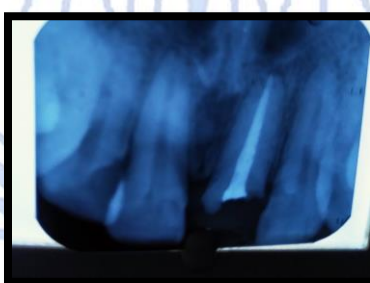
Picture-2B

Obturation was done using cold lateral condensation method (Picture-2B).

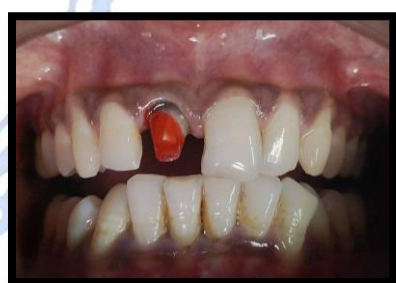
Picture-2C

After 7 days patient was recalled and gutta-percha was removed by No. 4 peeso-reamer (MANI,INC. Japan) leaving 4 mm GP apically. As a metal post core was planned finish line of the crown was placed subgingivally using torpedo bur on the buccal side and flat end tapered fissure round bur on the palatal side respectively. Ferrule was placed 1 mm above the finish line of the crown. A woden wedge of medium size was taken and was cut using No.15 BP blade for the proper adaptation in and the canal. Separating media was applied in the canal. PATTERN RESIN LS (GC Corporation , Tokyo) was applied to wedge and was inserted into the canal. After setting of the pattern resin wedge was taken out and fit was check by reinserting it into the canal.<sup>[8]</sup> Once proper fit was checked parent resin was applied over the wedge upto the ferrule margin to build up the core. Once post core was made it was invested and casted. Metal post core was cemented using luting cement (Meron,VOCO GMBH, Germany) (Picture-2D), elastomeric impression was taken and crown was fabricated (Picture-2E).

In the second case a new technique for the fabrication of metal post and core had been used. The main advantage of using pattern resin is that it is highly dimensionally stable and accurate.<sup>[15]</sup> It also reduces the clinical timing and handling is very easy and this can

also be used in multi rooted teeth.<sup>[8]</sup> In this case 2 mm ferrule was provided all over the tooth structure. The ferrule acts as a 360° metal cover all over the teeth. The function of the ferrule provides hugging action which reduces the wedging effect of a tapered dowel and resists the lateral forces.<sup>[16]</sup>

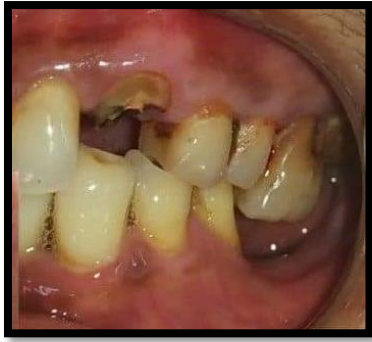
Picture-3A

A 28 year male patient came to the department with the complaints of broken front teeth. On intra oral examination it was noted that the patient had Ellies class III fractured maxillary left canine with loss of significant teeth structure (Picture-3A). Radiographic examination showed the tooth was endodontically treated with no peri apical radiolucency. Periodontal condition of the tooth was good with adequate bony support, good oral hygiene and presence of 4 mm of keratinized gingiva.

As only 1 mm of tooth structure was present both buccally and palatally and tooth was endodontically treated crown lengthening with post and core fabrication was planned to

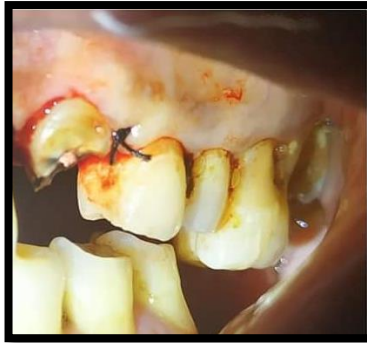
Picture-3B

On the next appointment transgingival probing was done around the intended tooth under local anesthesia. It was found that 2 mm of soft tissue present above the alveolar crest. Pointed instrument was used to create the bleeding spots which would act as level of incision. Using a no. 15 Bard-Parker blade, the internal bevel incision was performed 2 mm above the gingival margin both on buccal and palatal aspect. A mucoperiosteal flap was raised. Osseous resection was performed using low speed hand piece and carbide bur under copious saline irrigation to maintain the biologic width. The flap was repositioned and single interrupted suture was given (Picture-3B).<sup>[9]</sup>

The fractured tooth in the third case was restored by clinical crown lengthening and fiber optic post and core fabrication. One of the main factors that should be considered in clinical crown lengthening is the maintenance of the crown root ration. As the canine has the longest root in the oral cavity, crown lengthening in such cases does not hamper the crown root ratio. The amount of keratinized gingiva present in this case was 4 mm. This amount was satisfactory as minimum of 3 mm of space between restorative margins and alveolar bone would be adequate for periodontal health, allowing for 2 mm of biological width space and 1 mm for sulcus depth.<sup>[17]</sup> The tooth was restored with fiber optic post with composite core. The main advantages of fiber optic posts are modulus of the elasticity, compressive strength, flexural strength and thermal expansion, similar to that of dentin. This reduces the chance of fracture and transfer less forces along the long axis of the teeth. In addition to that, due to their natural translucency the esthetic outcome of fiber optic post are much superior.<sup>[18]</sup>

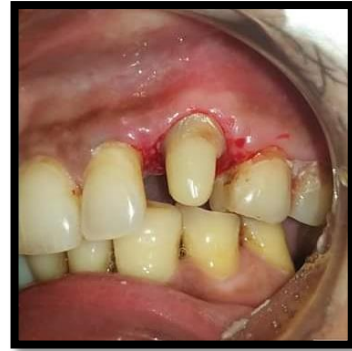
Picture-3C

On the same day gutta-percha was removed by No. 4 peeso-reamers (MANI, INC. Japan) leaving 4 mm GP apically. Gingival finish line was prepared and core ferrule was placed 2 mm above the gingival margin. Fiber optic post (Angelus Reforpost No.3, Angelus Indústria; Brazil) was inserted the canal and fit of the post was checked. Bonding agent (3M ESPE Single Bond Universal Adhesive, 3M India Limited) was applied in the canal and was cured for 10 seconds. Post cementation was done by dual cure cement (RelyX U200, 3M India Limited). The post was seated and excess material removed after light curing. Core build up was done with composite (Filtek Z350 Xt, 3M India Limited). Tooth preparation was done (Picture-3C). Temporary crown was fabricated over the prepared teeth from the wax mock up. After 14 days patient was recalled and suture was removed. Maxillary and mandibular elastomeric Impression was taken and crown was fabricated (Picture-3D).
