## Prosthetic and Endodontic Retreatment of Maxillary Premolars: A case report.

### Abstract

Endodontic in combination with prosthetic treatments are often done to restore the form and function of carious teeth. But such treatment does fail because of various reasons. If diagnosed properly such cases can be treated by endodontic and prosthetic retreatment. The following case report discuss regarding the treatment protocol of endodontic and prosthetic retreatment of maxillary premolars.

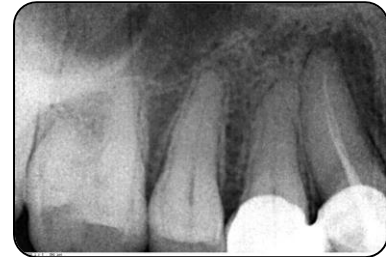
**Fig. 2**

A 25 years old male patient visited our clinic with chief complaints of pain and sensitivity in the right upper back teeth region. Patient gave the history of endodontic treatment of the teeth 2 years back followed by fabrication of prosthesis. On examination there was gingival swelling in relation to the right maxillary first premolar. Joint crowns which were present i.r.t right maxillary first and second premolars were poorly adapted to the underline crown margins. There was also ceramic fracture present in the occlusal portion of the joint PFM crowns (Fig. 1 and Fig. 2). Peri-apical radiolucency was present in the radiograph involving both first and second molar. Obturation of the first premolar was 4 mm short of the radiographic apex (Fig. 3). Patient was briefed about the failed endodontic and prosthetic treatment and was explained about the endodontic and prosthetic re-treatment. Tungsten carbide crown cutting bur (Coltene Whaledent Pvt Ltd, India) was used to break the junction of the joint PFM crown and to make vertical cut across the margin of the crowns. Sliding hammer type crown remover with angle tip C4 (GDC Automatic Crown Remover Standard, GDC Fine Crafted Dental Pvt. Ltd; India) was used to remove the crowns.

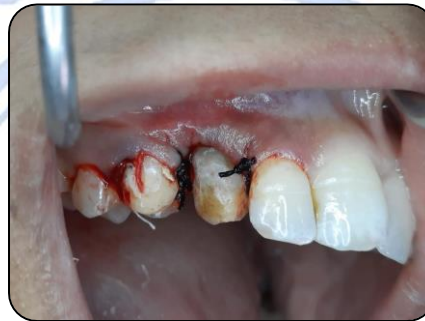
**Fig. 4**

After 1 week patient was recalled and bio mechanical preparation was done with the Protaper nickel-titanium rotary instruments (Dentsply-Maillefer, Ballaigues, Switzerland) and RC-Prep (Hawe Neos Dental, Bioggio, Switzerland). Copious irrigation with 5% sodium hypochlorite was performed during shaping and cleaning procedure. Again, the canals were filled non-setting CaOH paste (Calcipulp, Specialites Septodont, Saint-Maur, France). On the next appointment canal was irrigated with 2% Chlorhexidine Gluconate Solution (Anabond Stedman Pharma Research Pvt Ltd; India) and 17% EDTA (DPI; India). The canals were dried with paper points, coated with Sealapex (Kerr Manufacturing Co.) and obturated using Obtura II system (Obtura Spartan, USA) (Fig. 4).

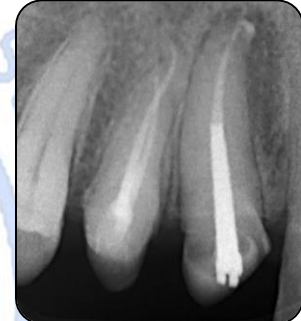
**Fig. 5**

On the next appointment transgingival probing was done around the intended tooth under local anesthesia. It was found that 2 mm of soft tissue present above the alveolar crest. Pointed instrument was used to create the bleeding spots which would act as level of incision. Using a no. 15 Bard-Parker blade, the internal bevel incision was performed 2

mm above the gingival margin both on bucal and palatal aspect. Piezo electric surgical tip (Ultrasurgery x, woodpacker;China) US1L was used at 25000 Hz with controlled flow of sterile saline (Flow rate - 80 ml/min) in the Piezotome to remove the bone. The flap was repositioned and single interrupted suture was given (Fig. 5).

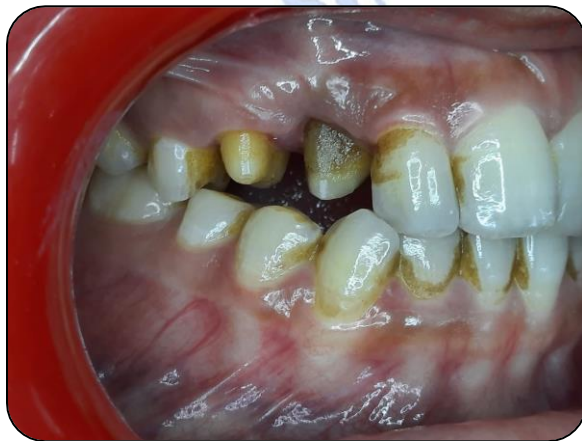
**Fig. 6**

On the same day gutta-percha was removed from first premolar by No. 4 peeso-reamers (MANI,INC. Japan) leaving 4 mm GP apically. Stainless steel post (Coltene ParaPost Stainless Steel, 0.90mm) was selected and inserted in the canal to check the fit. Dual cure cement (RelyX U200, 3M India Limited) was used for post cementation. The catalyst and base components of the material were mixed and applied following manufacturer's instruction. The post was seated and excess material removed before light curing (Picture-1D). Core build up was done with composite (Filtek Z350 Xt, 3M India Limited). Gingival finish line was prepared in both teeth (Fig. 6). Temporary crown was fabricated from wax mock up and it was cemented with temporary cement. Patient was recalled after 14 days and sutures were removed (Fig. 7). Maxillary and mandibular elastomeric Impression was taken and crown was fabricated (Fig. 8).
