Strategic management of chronic pulpitis with post and core restoration: A clinical approach to anterior tooth rehabilitation.

Keywords: Chronic pulpitis, post and core, fiber post, composite core buildup, full veneer crown.

Bibliographic details: Journal of Orofacial Rehabilitation Vol. 4(3), Dec 2024, pp. 40-43.

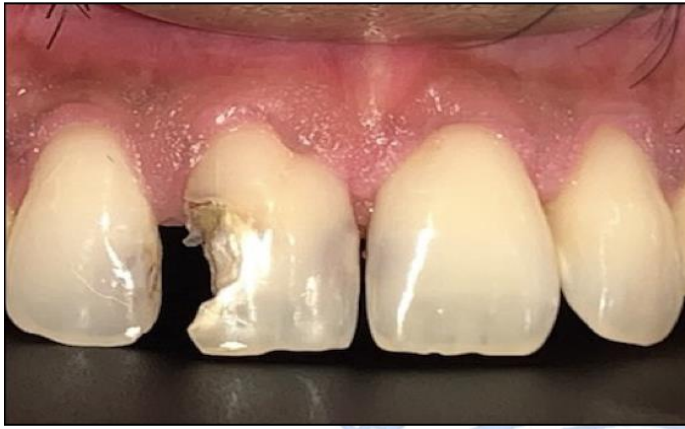
Figure 1

On clinical examination, tooth #11 exhibited a dislodged composite restoration and visible decay along the margins (Figure 1). Radiographic examination, including periapical X-rays, showed extensive radiolucency involving the enamel, dentin, and pulp, consistent with chronic pulpitis. Importantly, no periapical pathology was detected, indicating that the infection was confined to the pulp and had not spread to the surrounding bone. With the diagnosis of chronic pulpitis in tooth #11 confirmed, the treatment plan was developed, which included root canal therapy followed by post and core restoration to rebuild the tooth structure and provide support for the final crown. The root canal procedure was performed under local anesthesia. After the removal of pulp tissue, the root canals were thoroughly cleaned, shaped, and sealed using gutta-percha and a resin-based sealer.

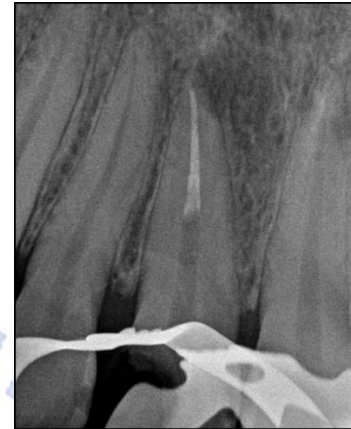
Figure 2

Following the root canal, post space preparation was the next step. To maintain a sterile environment, a rubber dam was placed. Piezoelectric reamers were used to carefully prepare the post space, ensuring an adequate fit for the fiber post while preserving as much of the natural tooth structure as possible (Figure 2). After ensuring the post space was prepared correctly, a prefabricated fiber post was chosen based on the dimensions of the prepared space. The post was tried in place and verified radiographically to confirm the correct fit (Figure 3).
