## Comprehensive esthetic smile rehabilitation using diagnostic wax-up–guided full-mouth fixed prosthodontic management in a young adult with dental fluorosis: A case report.

### Abstract

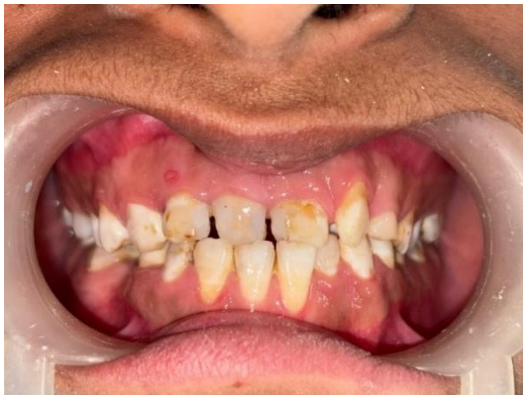
Figure 1

- Generalized dental fluorosis (Fig. 1)
- Ill-formed maxillary and mandibular anterior teeth.
- Anterior crossbite involving teeth 11, 21, 31, 41, and 42.
- Retained deciduous canine 63.
- Previously endodontically treated teeth were 11,12,17,21,24,26,35,37,46.

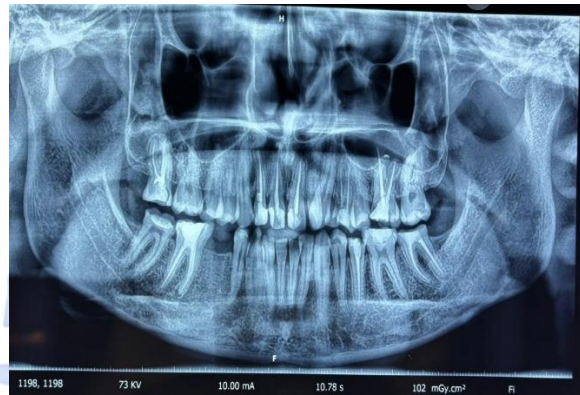
Figure 2

1. An orthopantomogram (OPG) was obtained to evaluate the status of the existing dentition, previously endodontically treated teeth, retained deciduous tooth, and the supporting alveolar bone before initiating prosthodontic treatment (Fig. 2).
2. Preliminary impressions of both arches were made, and diagnostic casts were prepared for treatment planning.
3. A diagnostic wax-up was performed on the study casts to establish ideal tooth

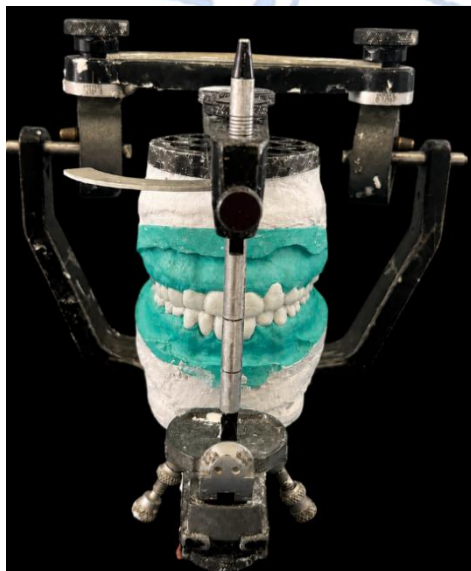
Figure 3

proportions, incisal edge position, current occlusal status, and overall esthetic outcome (Fig. 3).

4. The diagnostic wax-up served as a blueprint for the definitive restorations and facilitated communication with the patient regarding the anticipated treatment outcome.

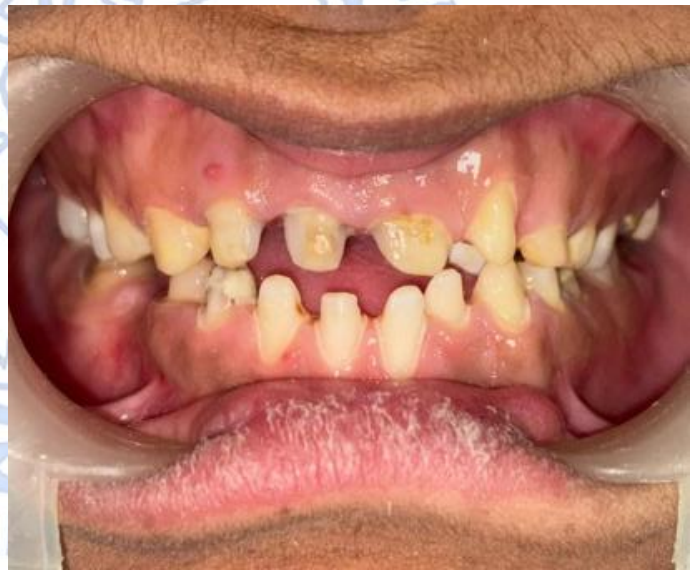
Figure 4

5. The planned anterior and posterior teeth were prepared for full-coverage porcelain-fused-to-metal (PFM) crowns following standard biomechanical principles (Fig. 4).

6. Adequate axial and occlusal reduction were achieved while maintaining uniform finish lines and preserving sound tooth structure.
7. Gingival displacement was performed wherever necessary, and definitive impressions were made using elastomeric impression material to accurately record the prepared teeth and surrounding soft tissues.

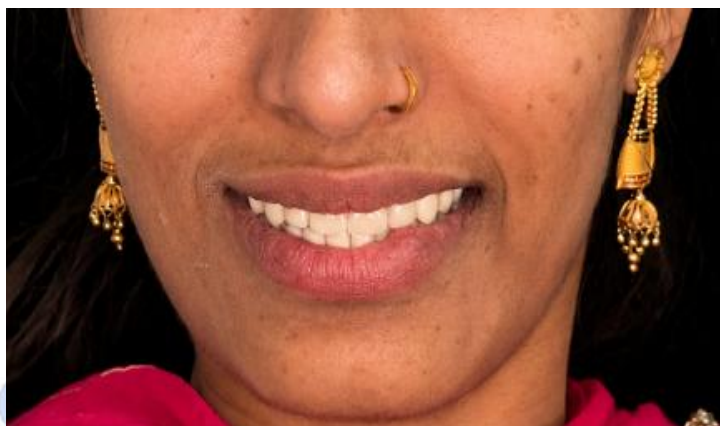
Figure 6

11. The definitive restorations were permanently cemented, followed by final occlusal refinement (Fig. 6). The patient was provided with oral hygiene instructions and advised to attend periodic follow-up visits for evaluation and maintenance.
