Esthetic restoration of dental fluorosis with ceramic veneers: A case report.

Bibliographic details: Journal of Orofacial Rehabilitation Vol. 1(1), Apr 2021, pp. 67-71.

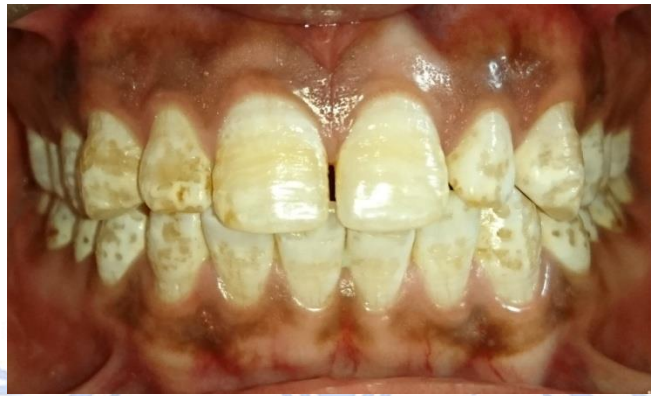
Figure 1

A 21-year-old male reported with chief complaint of stained teeth (Figure 1) History revealed that his native village has endemic fluorosis. According to Dean's fluorosis index, the case was classified as SEVERE.^[7] There was midline diastema. No gross TMJ derangement was detected. The patient had no interference during protrusive or lateral movements. Overjet and overbite was optimum (2mm). Treatment plan decided was indirect porcelain veneers with lingual wrap technique for maxillary and mandibular anterior teeth.

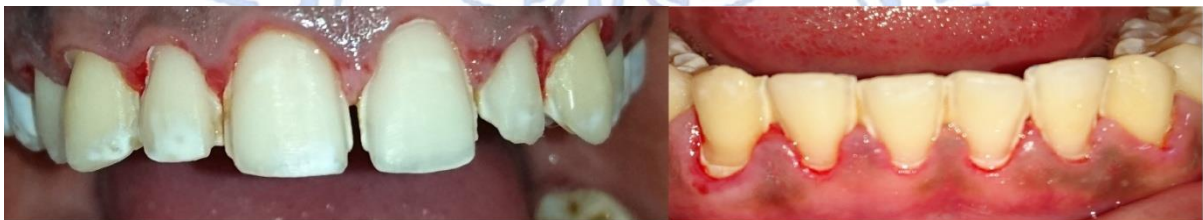
Figure 2

After diagnostic impressions, teeth preparation started. Depth-cutting diamond burs were used to keep depth of preparation 0.5 mm. Cervically preparation was subgingival to maximise esthetics (Figure 2). Proximal preparations were kept short of contact points facially for all teeth except maxillary central incisors (Figure 2). The incisal preparation was a lingual wrap design where the incisal edges were reduced by 1mm and preparation extended lingually/palatally by 0.5 mm from the reduced edge. The lingual preparation was terminated in butt joints. Shade selection (VITA Classical shade guide) was done under natural daylight.

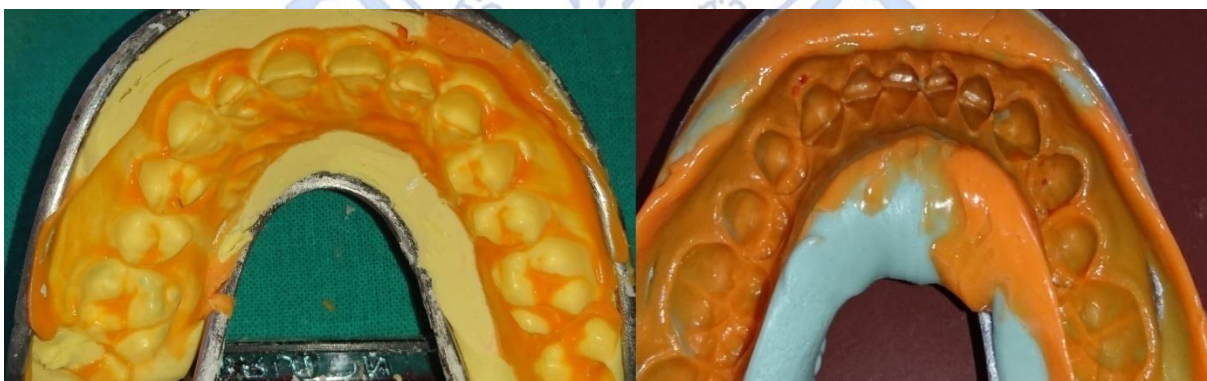
Figure 3

Impressions were made for both arches on same day using putty and light body (ZETAPLUS PUTTY AND KIT, ZHERMACK SPA, ITALY). Fig3 Prior to that, gingival retraction was done (ULTRAPAK KNITTED RETRACTION CORD #000, ULTRADENT, GERMANY). Since, the veneers were cemented in 48 hours, temporisation was not done. The laminates (IPS Empress Emax) (Figure 4) were tried in using a drop of glycerine. The shade was analysed, finish lines assessed and incisal interferences in maximum intercuspation corrected. Following adjustments, they were glazed and cemented.

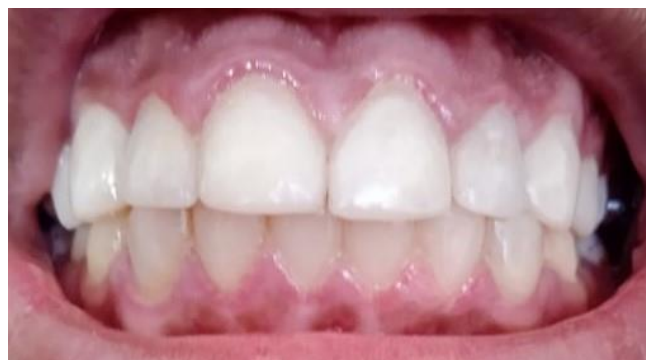
Figure 7

Porcelain Etch and Silane, Germany) for 90 seconds and silane coupling agent (Ultradent Porcelain Etch and Silane, Germany) applied for 60 seconds. Tooth surface was cleaned using pumice, isolated and etched with 37% phosphoric acid for 60 seconds, rinsed thoroughly and air dried. Bonding agent (Single Bond Universal Adhesive, 3M ESPE, USA) was applied. Resin cement (Relyx Ultimate Adhesive Resin Cement, 3M ESPE, USA) was applied on the inner surfaces of the laminates and placed on prepared teeth. Flash curing for 10 seconds was done and flash cement removed. Final curing was done for 60 seconds facially and incisally. Excess cement was removed. Occlusion was checked in maximum intercuspation and eccentric movements. Following necessary adjustments, polishing was done and patient dismissed with oral hygiene instructions. Final result yielded satisfactory esthetics (Figure 5). The post-operative pictures (Figure 6) shows that results were very much satisfactory. A four year follow-up of the patient showed marginal discolouration in maxillary centrals (Figure 7) The oral hygiene was satisfactory without debonding or fracture of the veneers.

Marginal discolouration, as in this case, may result most commonly from poor colour stability of dual cure resin or marginal cement breakdown causing leakage. Use of light cure cements ensures better colour stability. Careful removal of excess cement with sharp instruments and finishing with burs and subsequent polishing may take care of marginal leakage. Studies have shown estimated survival probability of porcelain laminate veneers over a period of 10 years is 91-95%, provided all parameters are maintained.^[10]
